MINISTRY OF TRANSPORT

REPORT ON THE DERAILMENT

18th April 1961

LAINDON and PITSEA

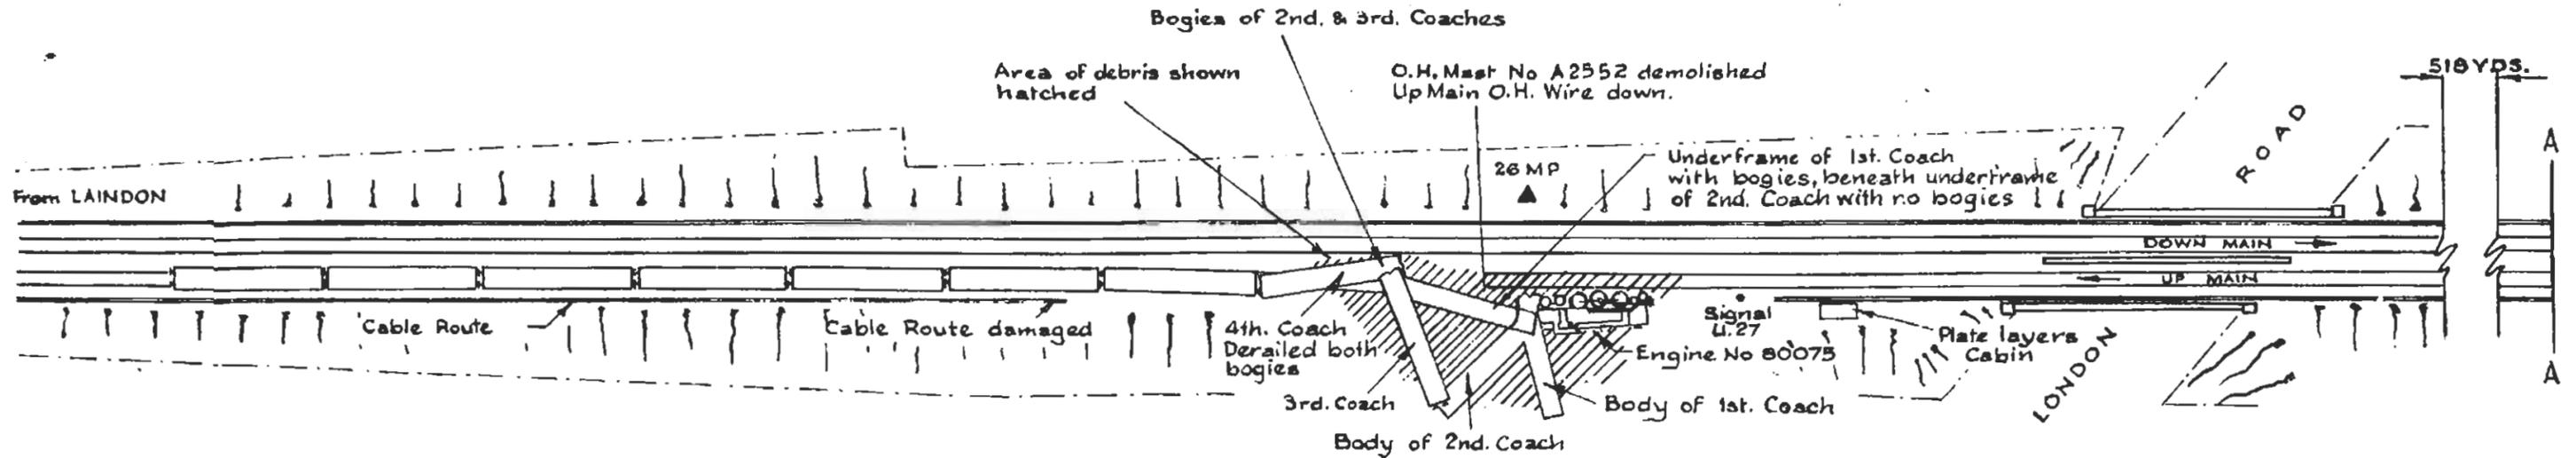
POSITION IN WHICH TRAIN CAME TO REST

The engine ran forward for some 60 yards and turned over on to its side presenting a solid obstruction against which the two leading coaches, which had wood framed bodies, were telescoped by the weight of the train behind them: the steel underframe of the second coach over-rode that of the first throughout its length, both bodies being torn off their frames, thrust away at an angle and largely destroyed. The train was screw-coupled throughout and the third coach did not remain in line, but was forced up off its bogie and swung round almost at right angles to the track, while the leading end of the fourth reared up and, remaining roughly in line, came to rest on a tangle of bogies that had become detached from the coaches ahead; the bodies of these two coaches remained fairly intact. The fifth coach was just entering the catch point when the train stopped, and it and the six coaches behind it stayed on the rails and were practically undamaged. Fortunately, about two-thirds of some 150 passengers were travelling in the rear seven coaches, but I regret to report that two passengers, one of them a railway servant returning home after work, lost their lives, and 46 passengers, including three railway servants, were injured, 26 of them being detained in hospital. Eight of these passengers were injured seriously and five of them are still detained in hospital.

10. The overturning and stopping of the heavy engine within 60 yards of the point of derailment resulted in the train behind it running at some speed into the equivalent of a fixed obstruction. Being screw-coupled and off the rails the coaches were free to telescope or to zigzag and this and the fact that their body frames were of wood made telescoping easy. The underframe of the second coach was lifted off its bogies, which were found under the third coach, and over-rode the underframe of the first from end to end, coming to rest almost exactly superimposed upon it. The bodies of these coaches were sheared off from the underframes, that of the first coach being thrust forward and to the right and that of the second being thrust forward and swung round through the best part of a right angle by the coach behind it, and both were destroyed. The third coach was lifted off its bogies and its leading end jack-knifed with the body of the second, to come to rest nearly at right angles to the track, with its leading end on the ground and its trailing end reared high on its own upended bogies. Its underframe and its body ends were badly damaged. The fourth coach was lifted off its bogies at the leading end and, continuing roughly forward, was thrust to the left and nearly overturned by the reaction of the third coach, to come to rest fouling the Down line. Its trailing bogie still supported its rear end and was only just derailed: its trailing wheels were almost touching the heels of the catch point switches.
