MINISTRY OF TRANSPORT

REPORT ON THE COLLISION

30th July 1961

PITSEA HALL OCCUPATION  
LEVEL CROSSING

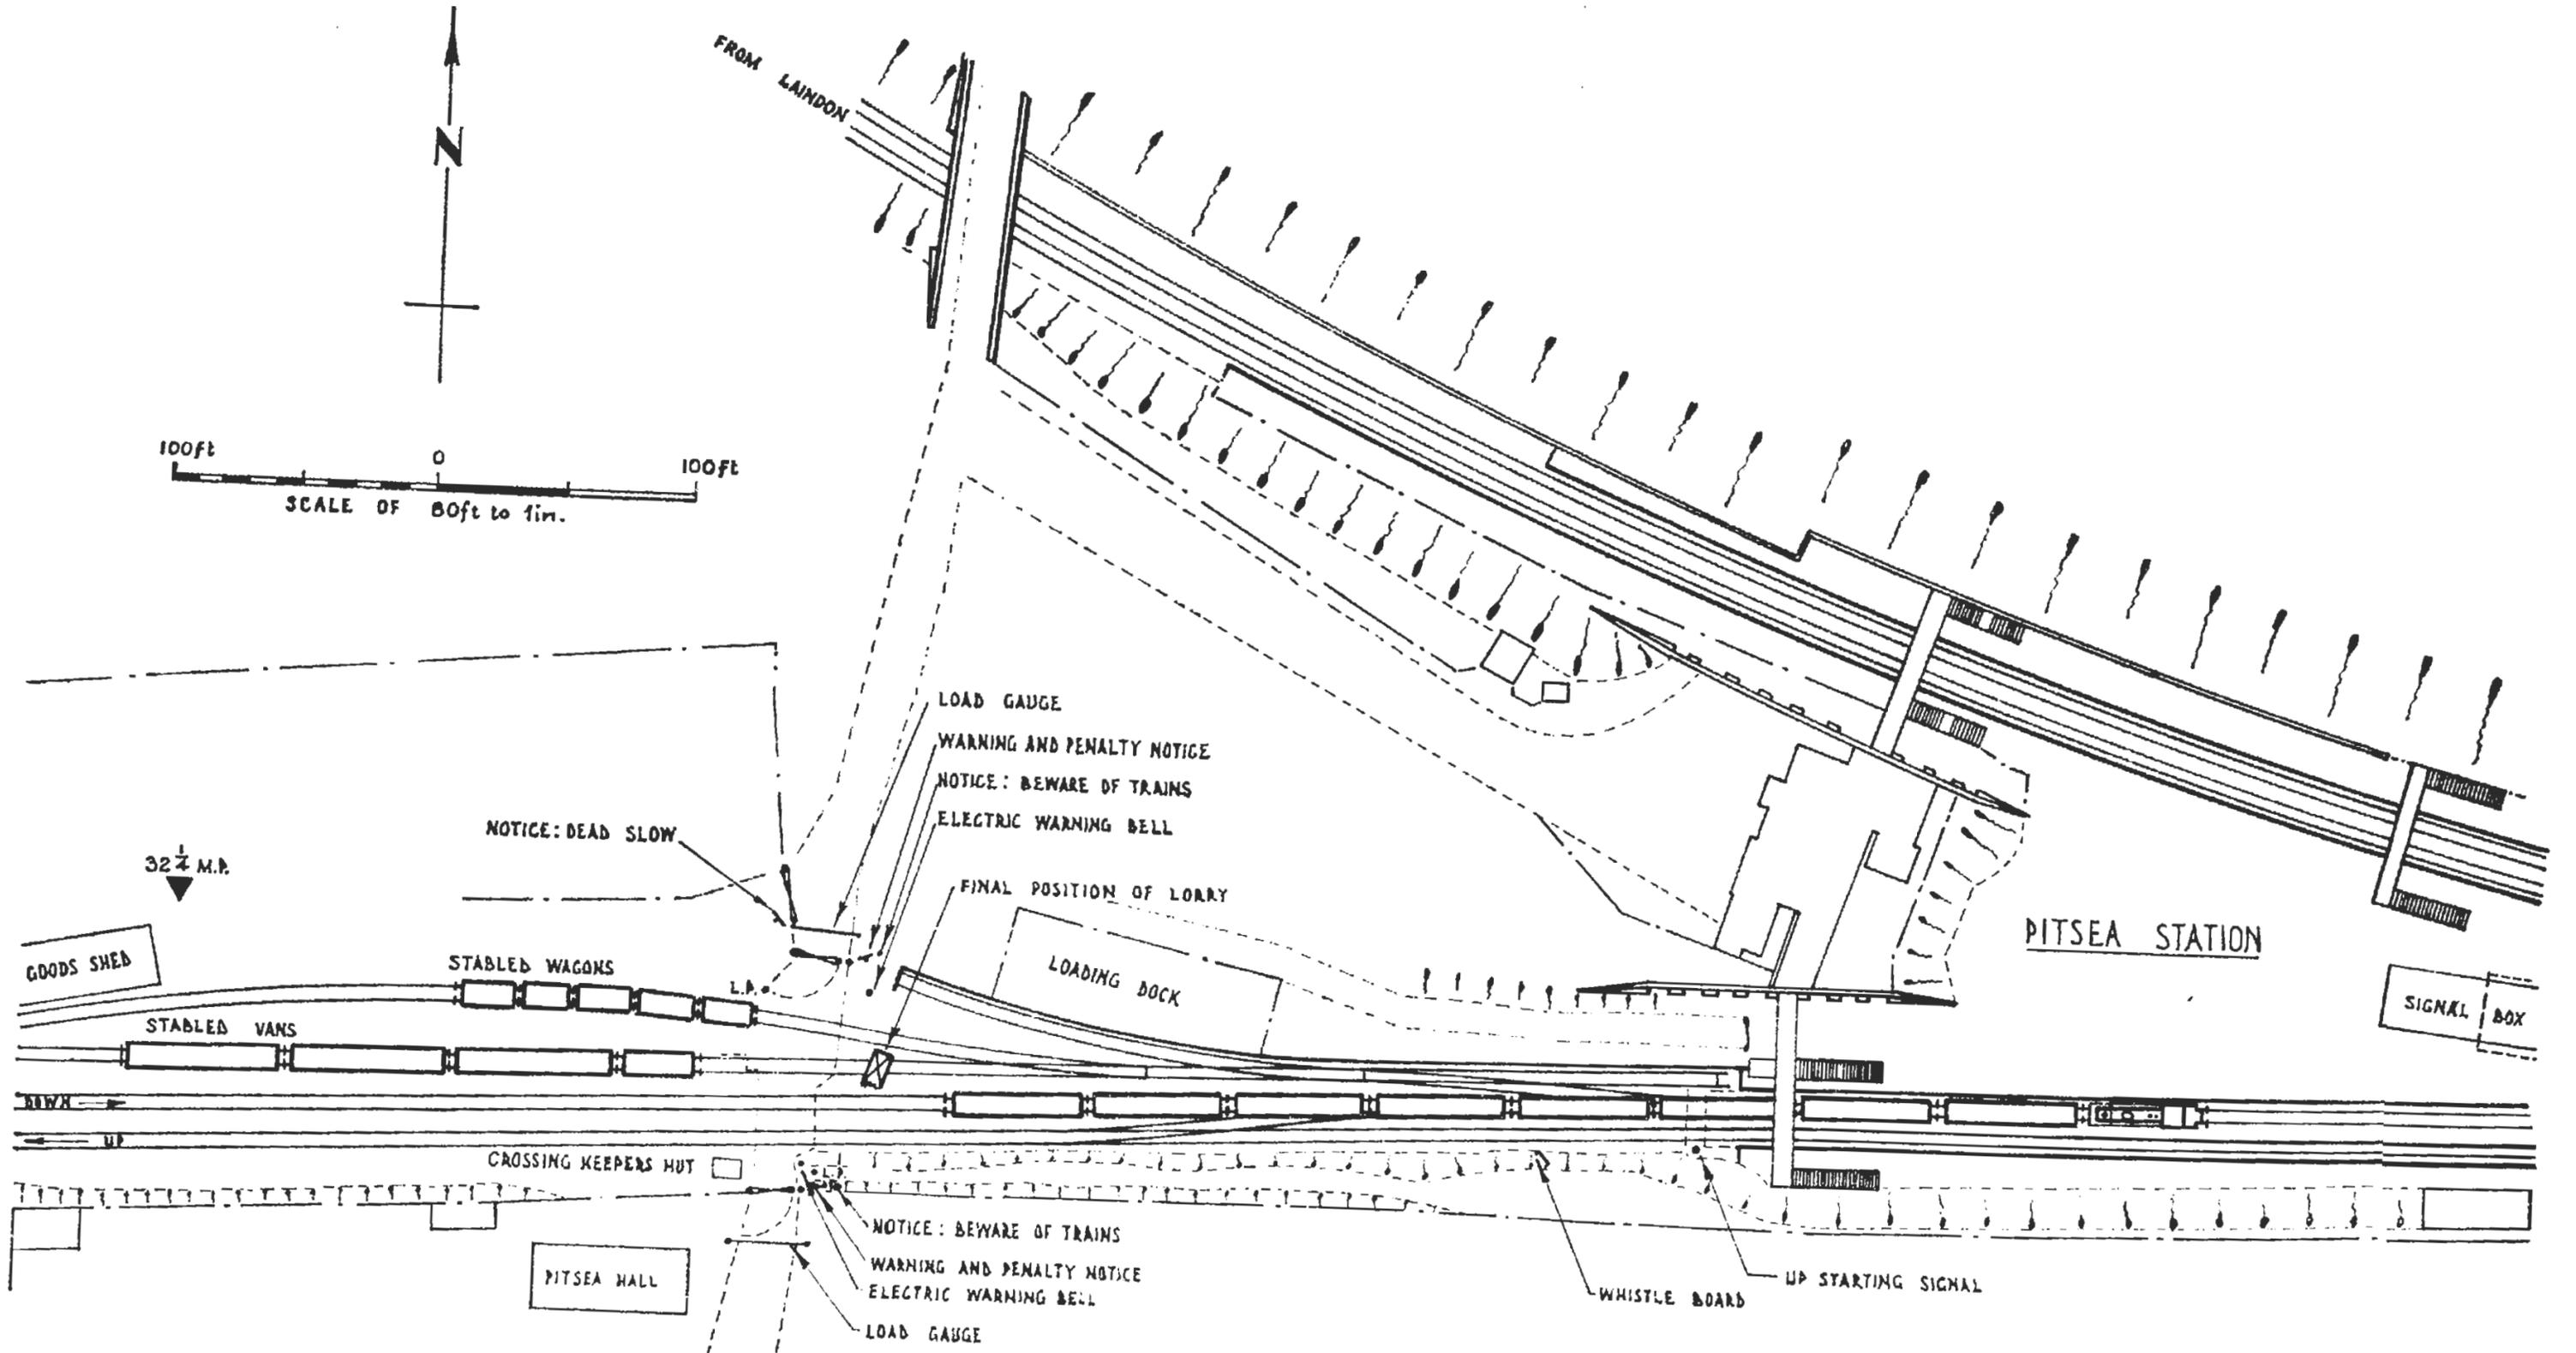
# ACCIDENT AT PITSEA HALL LEVEL CROSSING — 30th JULY 1961

3. This level crossing, which carries appreciable road traffic, is manned by day during weekdays, but not on Sundays. The sketch map on the facing page shows the arrangement of the level crossing; it is situated at the country end of the Tilbury Loop line close to Pitsea station where this line re-joins the main line to Southend, and is between the Up starting colour light signal at the end of the Up platform 110 yards away, and the Down home colour light signal which is 105 yards away towards Tilbury. These signals were installed in place of semaphore signals, in approximately the same positions, in November 1960 as a part of the modernisation scheme. The signal box, on the main station platform in the 'V' between the two routes, is 210 yards from the crossing; the view between it and the crossing, however, is hampered to some extent by the stairs of the footbridge between the Tilbury Loop platforms and by stabled wagons in a loading dock on the Down side of the line.

5. As will be seen from the map, the gates are set well back from the running lines, the one to the North being outside two sidings on which rolling stock is frequently stabled. They are of field type, 11 ft. wide; the south one opens away from the railway and the north one towards it. 4 ft. wide wicket gates are provided in line with the main gates. The distance between the gates is 30 yards, and the distance between the Down line and the adjacent siding on which vans were stabled to within 10 yards of the crossing at the time of the accident is 7 ft. 4 ins. between running edges of rails.

28. It is clear that the lorry came on to the crossing from the concealment of the stabled railway vans as the train was very close to it, and I am satisfied that there was nothing that the train men could have done to prevent the accident other than to have whistled continuously on the approach to the crossing. If Driver Anderson had done this the lorry driver might have heard it above the noise of his engine, though I think the sound would have been muffled by the stabled vans to an appreciable extent. Drivers, however, are not expected to whistle continuously when approaching such crossings, and there is no doubt that strong complaints of nuisance would be made if they were required to do so here. The distance of 175 yards travelled by the train under a full brake application after the collision is commensurate with Driver Anderson's estimate of speed of 30 m.p.h.

31. I do not believe that the clapper of the gong failed to work on this occasion. The initiating point for it is two miles away, however, and it would have been working steadily for about three minutes before the accident happened. So long a warning may be of value to the gateman, but road users will tend to pay less heed to it than they would to a shorter, more urgent one. It would be better if the warning of the bell, which has now replaced the gong, were to sound for only about 20 seconds before the fastest train reaches the crossing, and I recommend that this be done. Adequate notice to the gateman will still be necessary, of course.

32. For the same reason I consider that the whistle board on the Down line ought to be placed only about 150 yards from the crossing. Though the speed of the line is 60 m.p.h. and may be raised in the future, nearly all trains stop at Pitsea, and those that do not must reduce speed for the permanent 15 m.p.h. restriction on the connections at the country end of the station. It is reasonable therefore to assume an average speed of 40 m.p.h. on the approach to the crossing for the fastest train, and since engine drivers habitually sound the whistle on the approach side of a whistle board (say at 50 yards from it) this will mean a warning whistle at least 10 seconds before the train reaches the crossing. This, in my opinion, is a much more realistic warning to road users than one given at 500 yards range, 25 to 30 seconds before the train reaches the crossing as happens at present. Moreover at this distance the whistle may well not be heard in unfavourable conditions.

33. When the crossing is attended there is no great objection to stock being stabled close to it on the siding adjacent to the Down line even though it obstructs the road user's view of approaching trains, since safety rests on the attendant. I think, however, that the Railways were unwise to let this be done when the crossing was not manned, since the obstruction of view then made it less easy for a road user to avoid an accident. I recommend that steps be taken to prevent stock being stabled close to the crossing on the siding next to the Down line when the crossing is not manned.

34. The above observations are concerned with improvements of detail to the crossing as it is, which can be carried out at once. The traffic over this crossing is such, however, that proper arrangements as for a public level crossing should be made. The crossing appears suitable in all respects for lifting barriers operated remotely from the signal box. If it is found that the obstruction to view of the overbridge stairs and stabled wagons in the loading dock is too great, the crossing could be equipped with closed circuit television. It would be better to position the barriers close to the Up and Down lines, and the Down sidings would have to be slewed slightly to achieve this. I recommend that this scheme be given serious consideration, and I hope that the local and other authorities who have contributed, by their policies, to the growth of road traffic over the crossing will bear in mind that such works are in excess of the Railway's statutory obligations, and will contribute to the cost.
